# California State Lands Commission

## Prevention First 2002

### Rehabilitation of State Lease 421

September 10, 2002

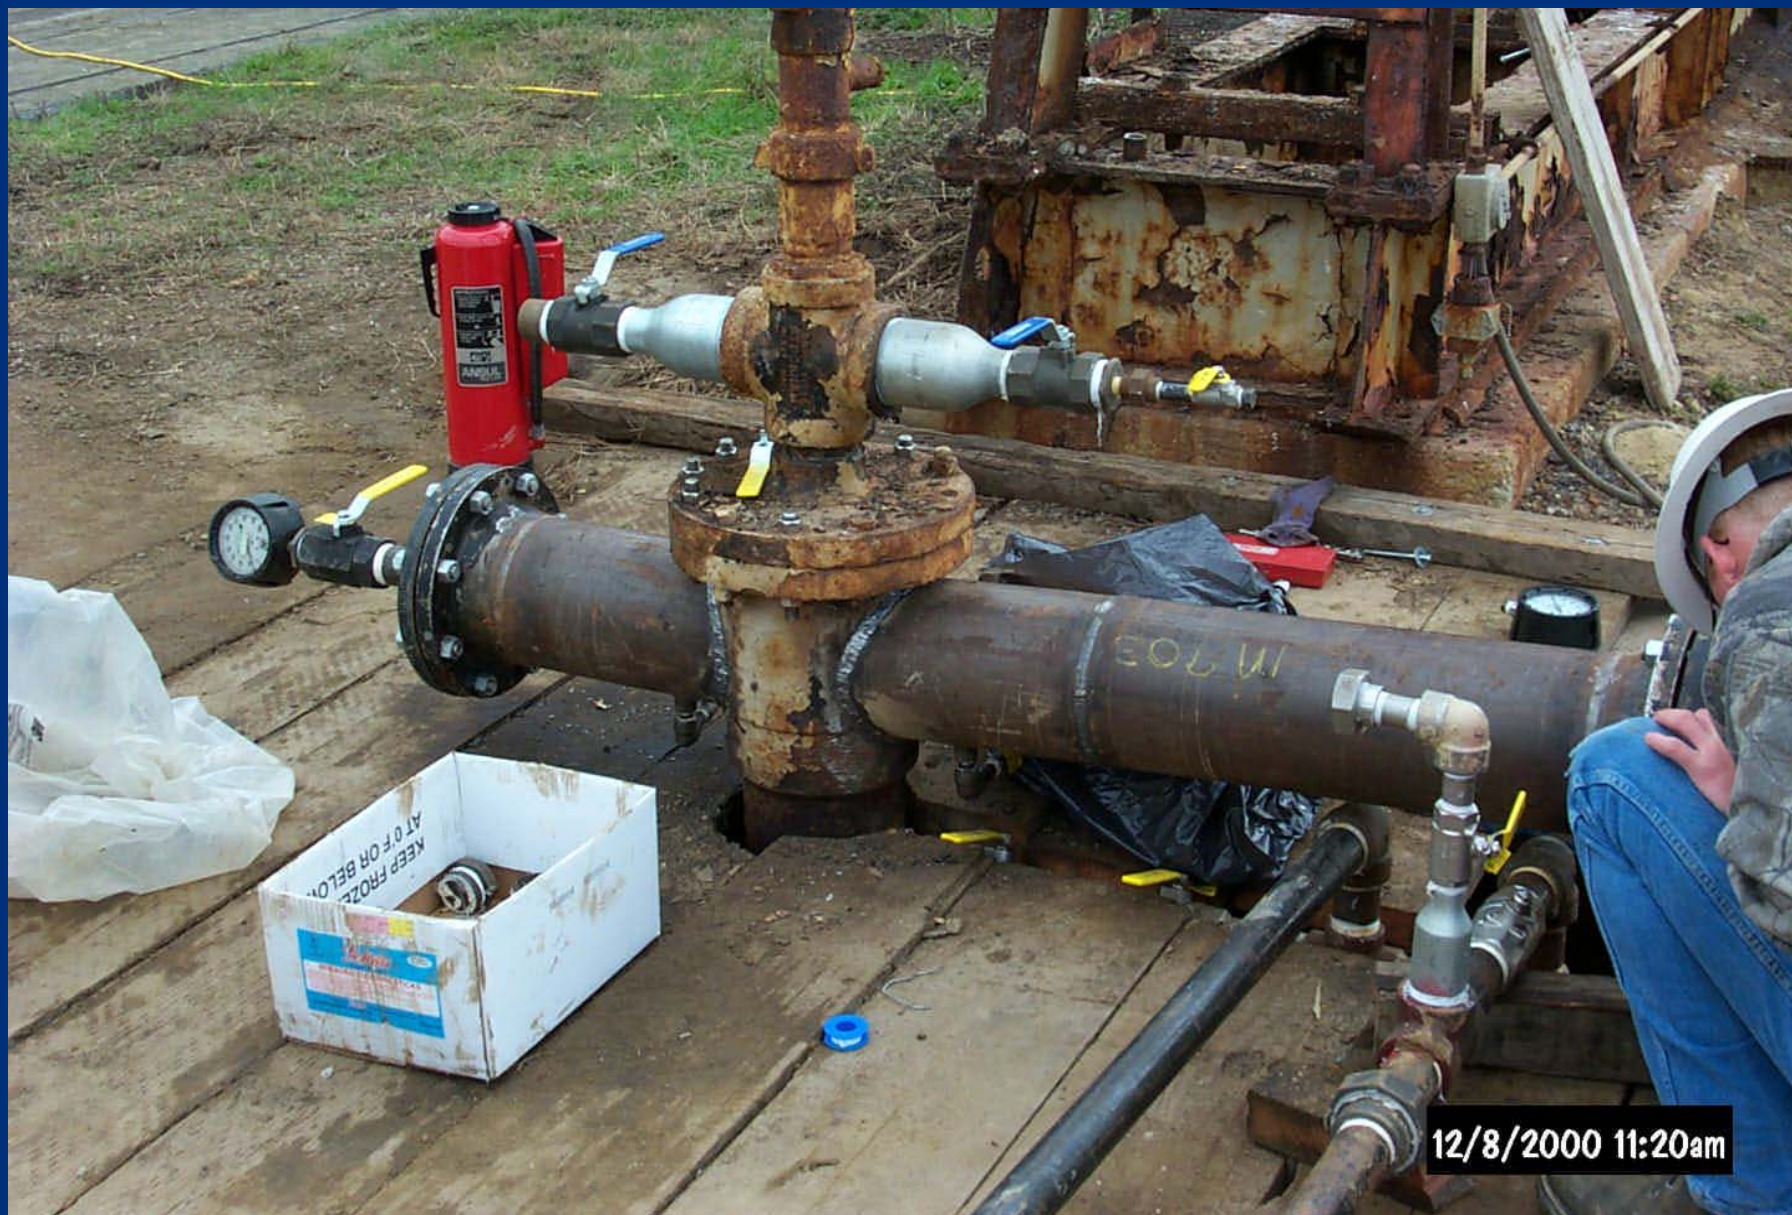
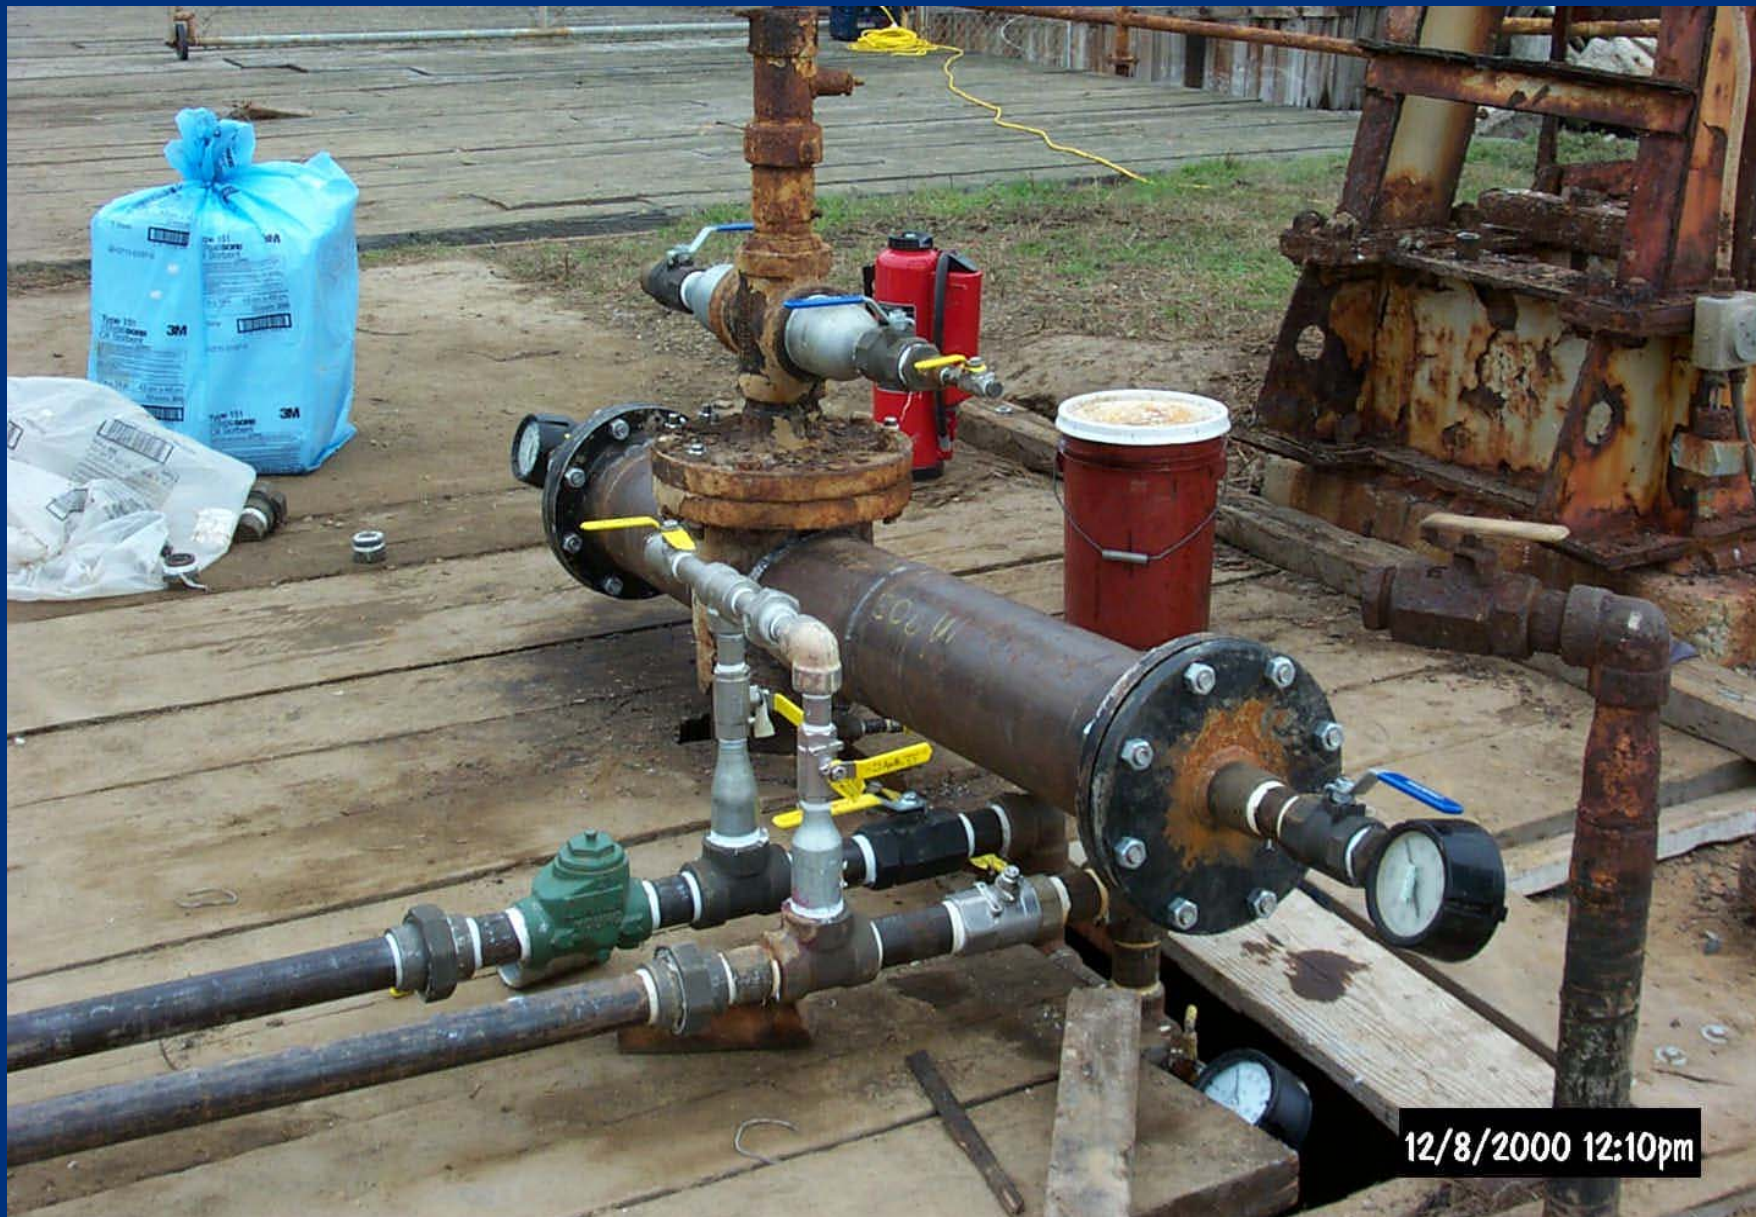
12/8/2000 11:20am

- Emergency Permit 00-EMP-006 was issued .
- Allowed for two 2" hard pipes to be placed from the wells to the Ellwood Onshore Facility. One to flow the wells and one to allow for injection of well kill fluid.

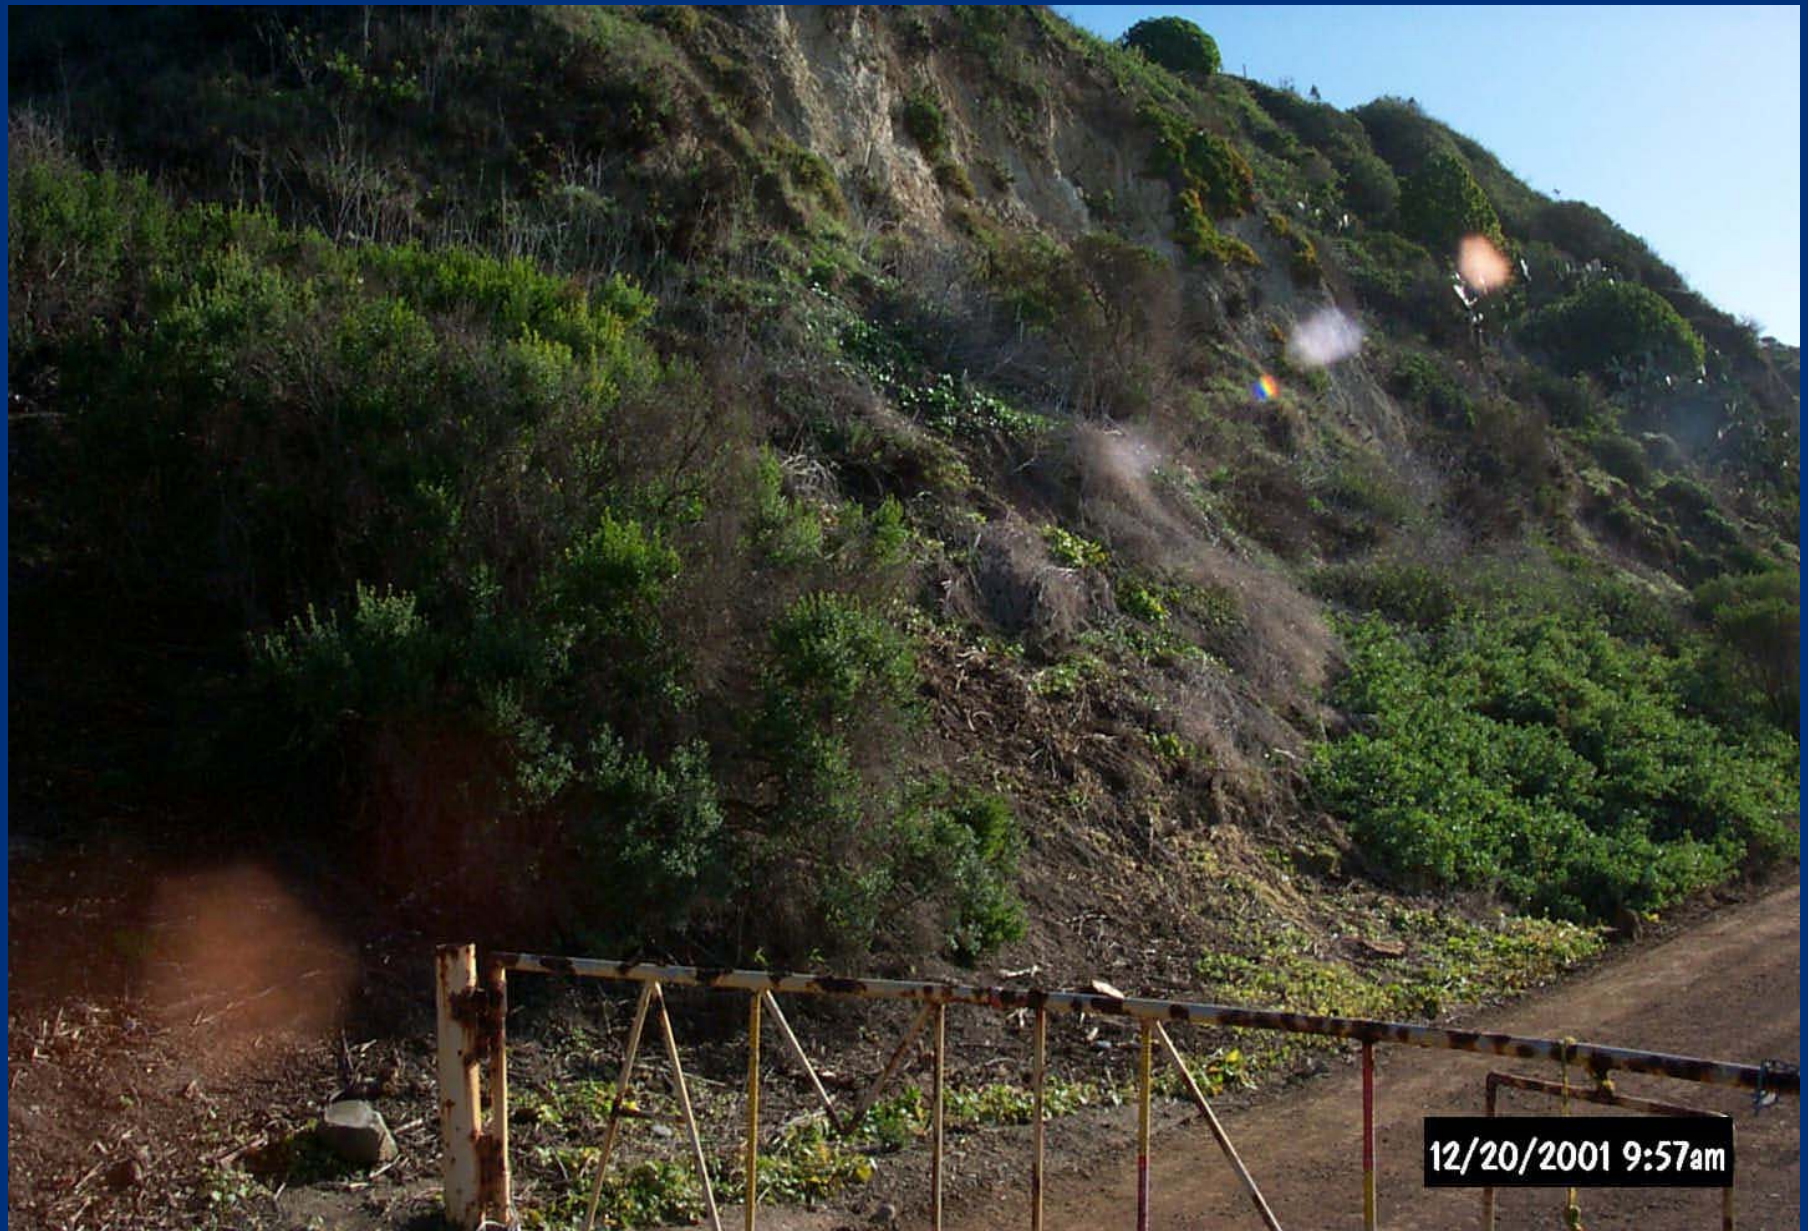
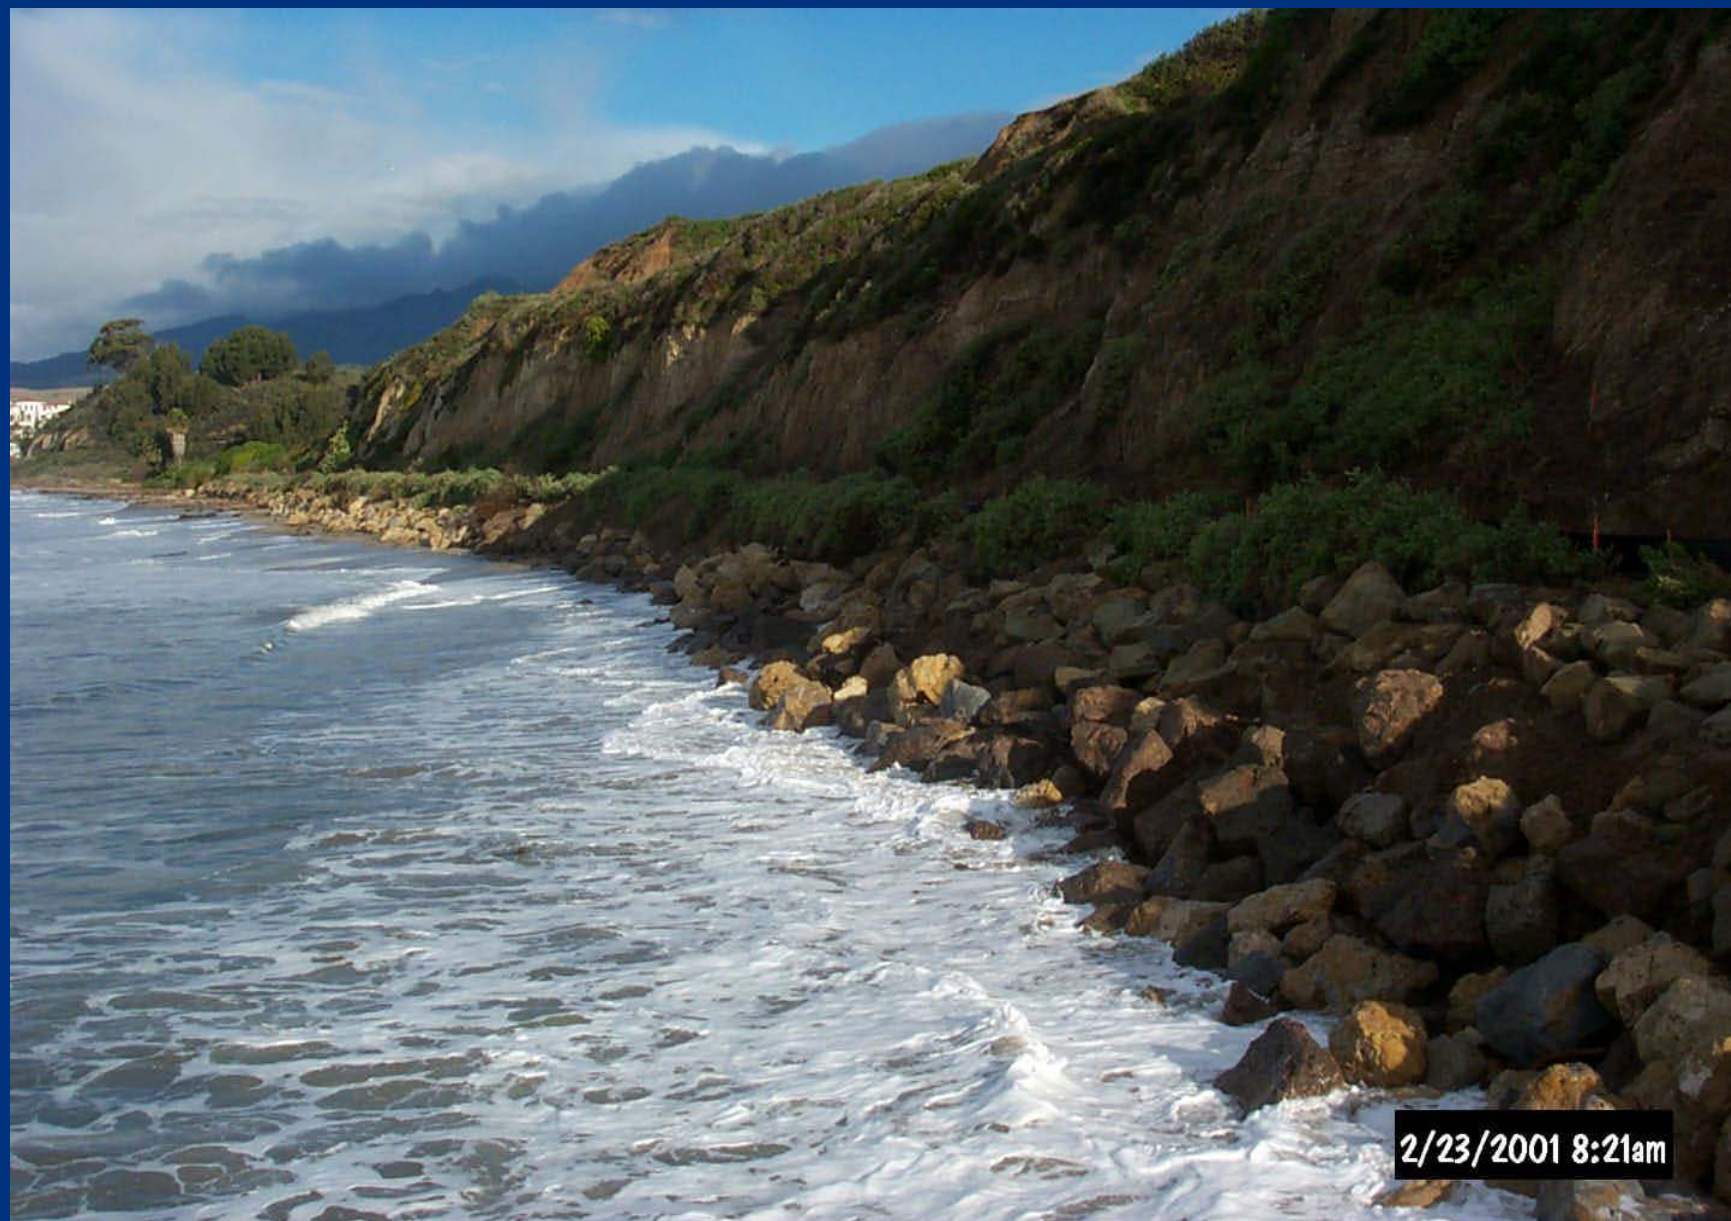
2/23/2001 8:21am

- Restricted to Reinforcement only, no expansion
- No further seaward encroachment allowed
- Remnant pipelines that were encountered were removed
- Three wetlands had appeared in the road area.
- Bluff side of the road had erosion that contained vegetation.

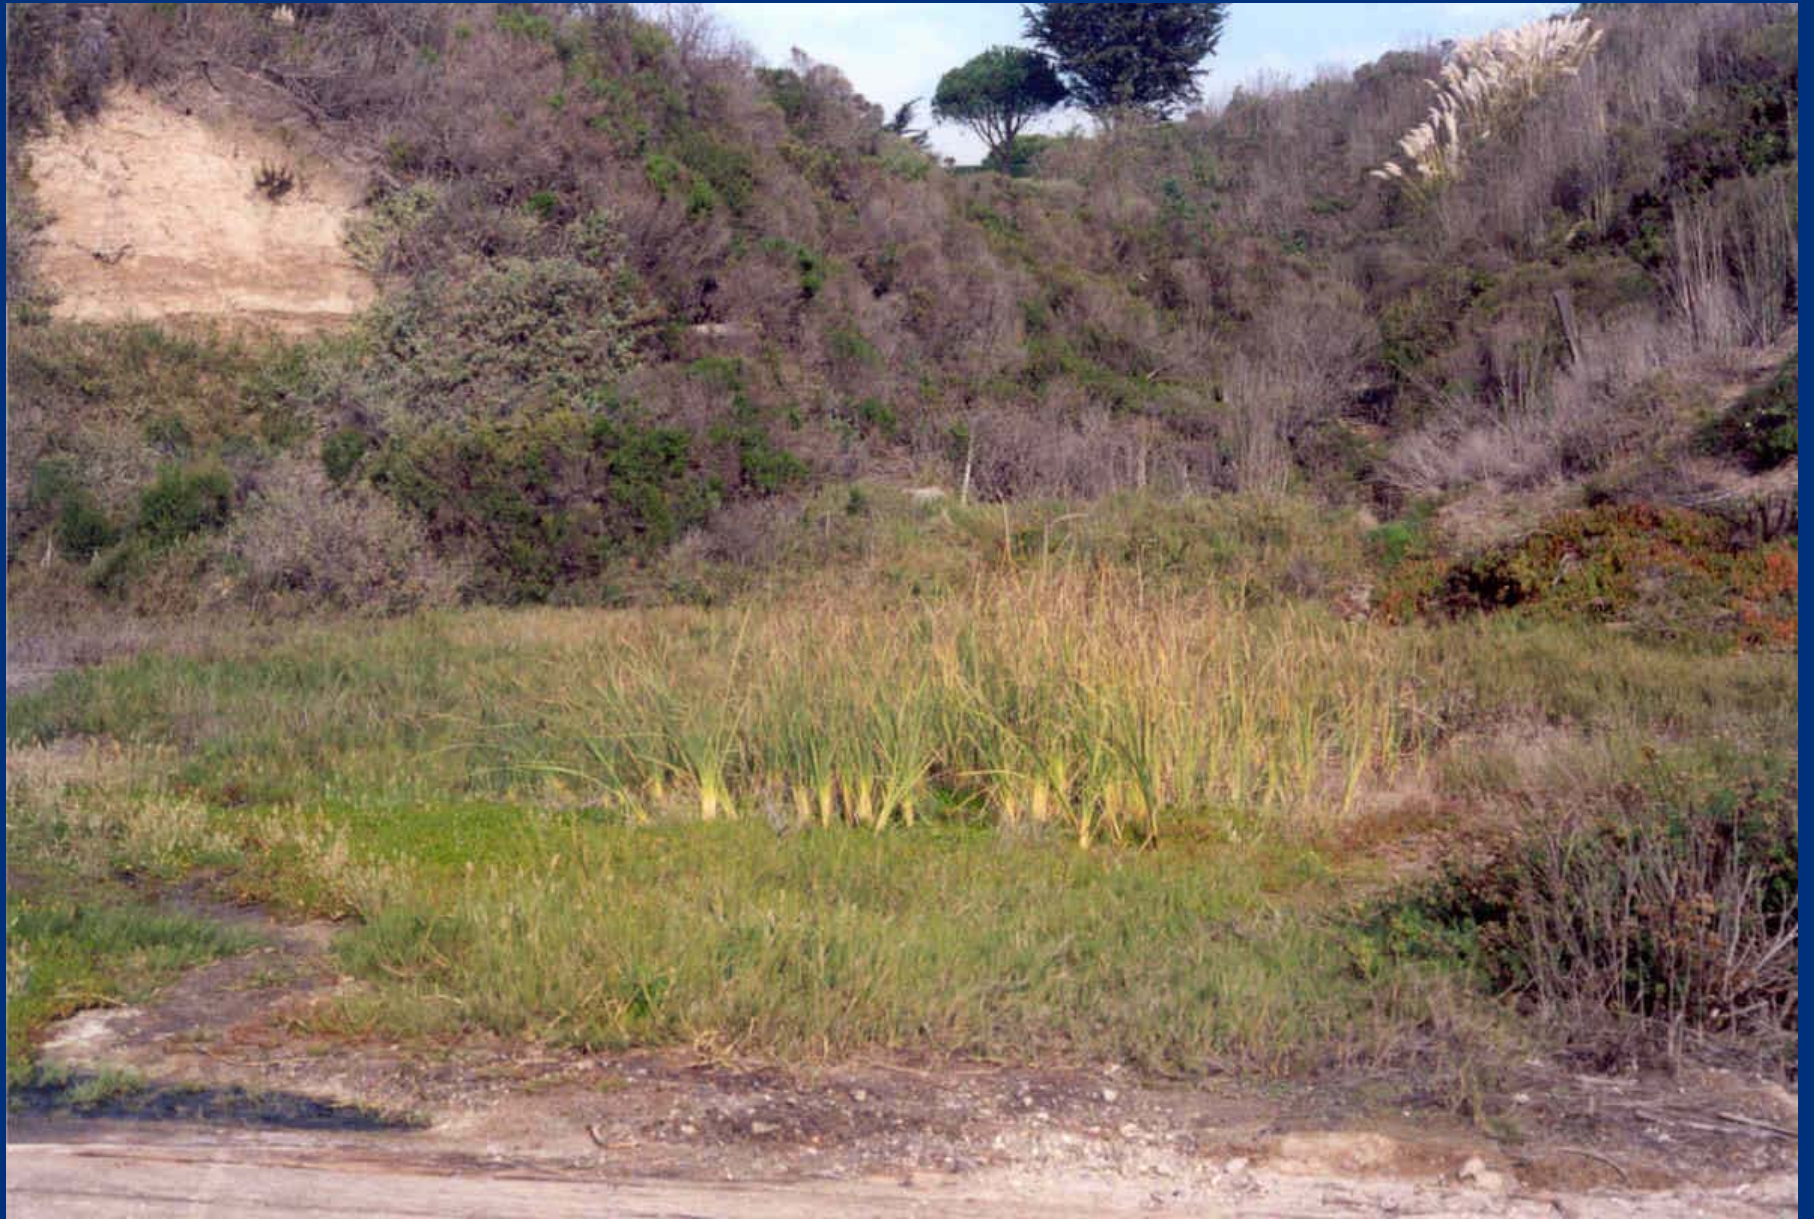
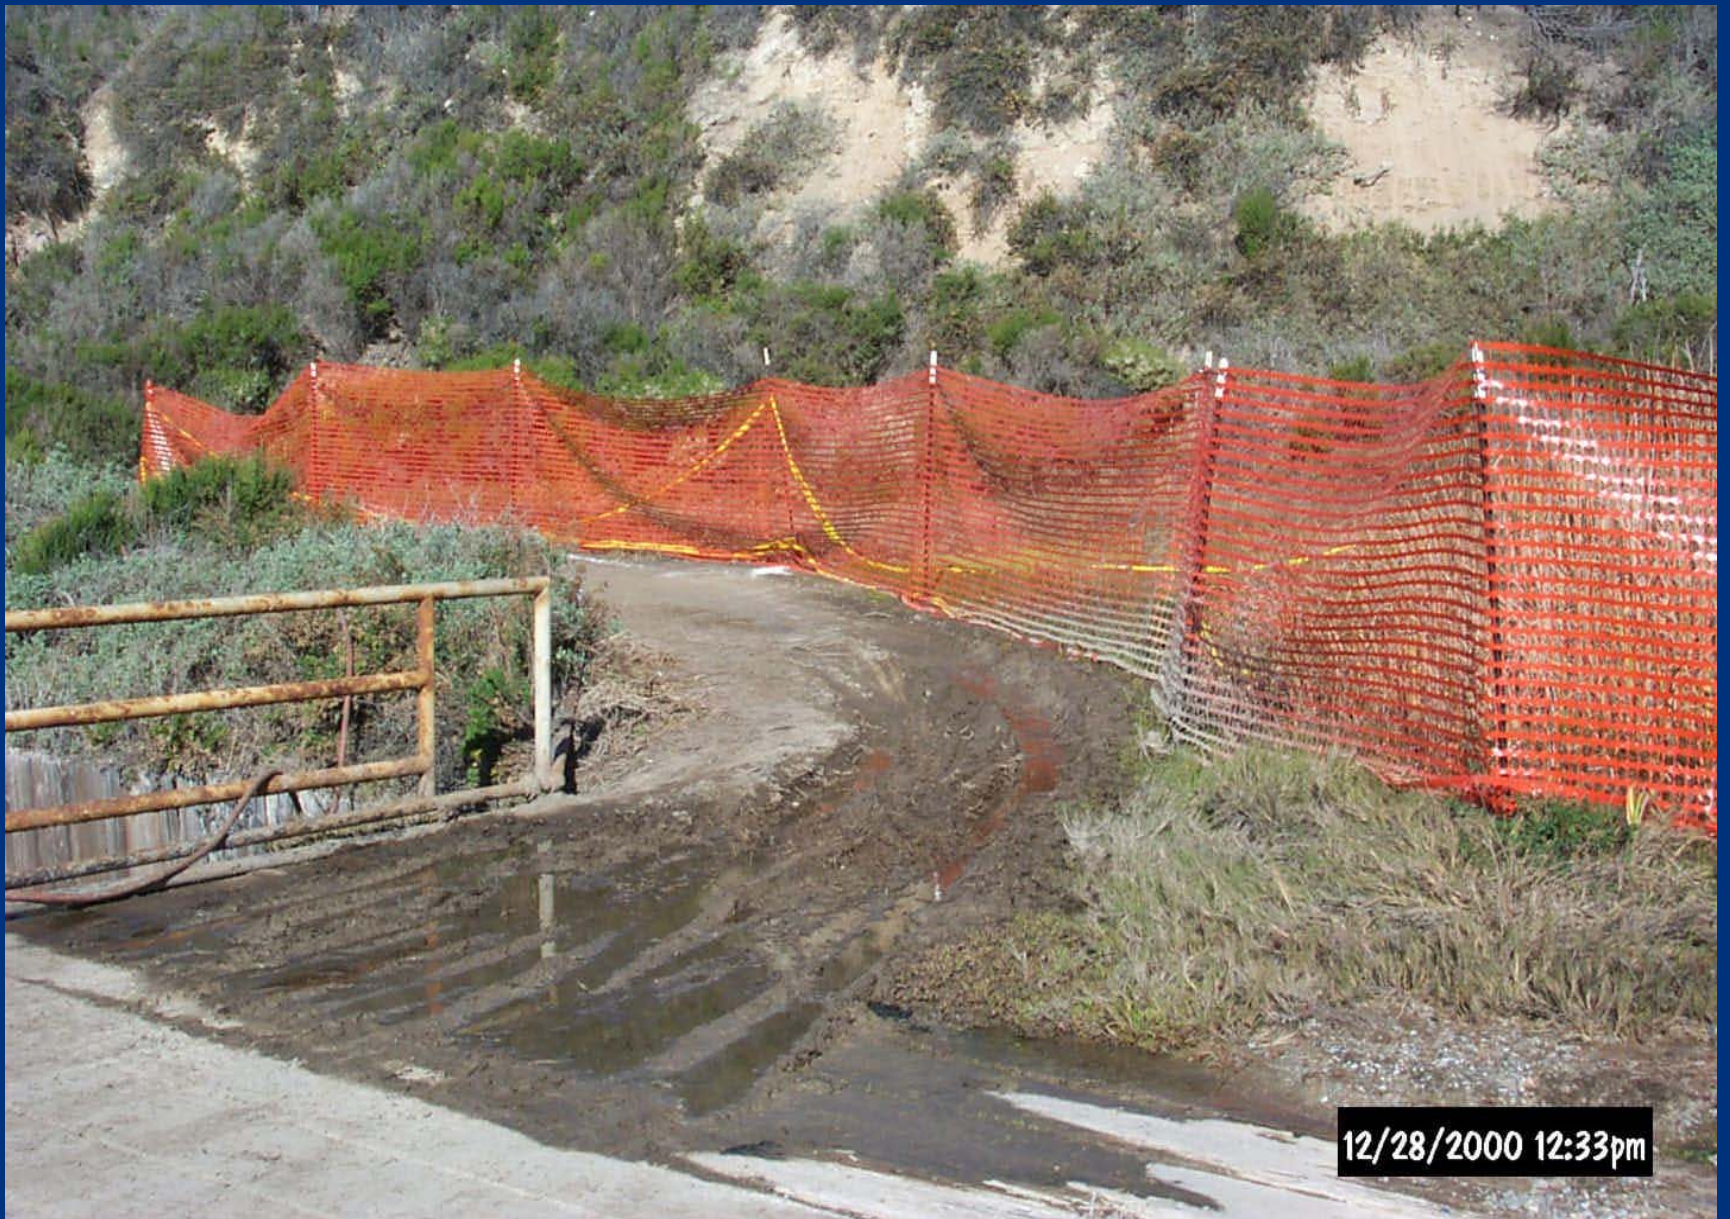
12/28/2000 12:33pm

- Wetland delineation report prior to construction.
- First 2 wetlands combined totaled 475 sq. ft.
- Third wetland covered 5,855 sq. ft.
- Prepare a Wetland Impact Minimization Plan to minimize impacts to the greatest extent feasible.
- Prepare an Offsite Wetlands Restoration Plan
- Restore wetlands at a 3:1 and 5:1 ratio.
